Recently I installed a receive four-square which will be used on 160m, 80m, and perhaps 40m. Although the four-square works very well, I was immediately faced with a problem which began more than a year earlier.

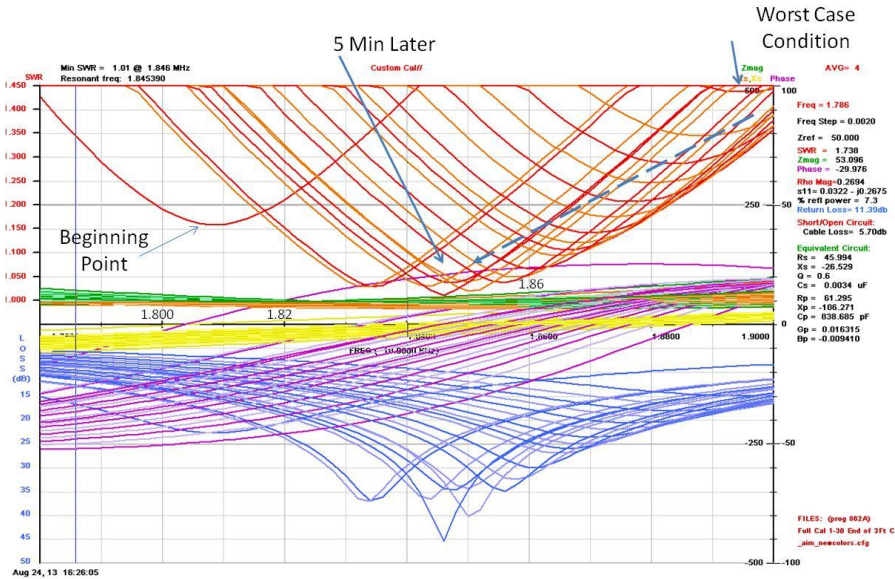
In yet another test, I reestablished the problem by continual transmission, and as quickly as possible, inserted my AIM-4170 one-port vector network analyzer. The graph below in Figure 1 is the result of this test. The beginning resonant frequency was ~ 1.825 MHz, annotated “Beginning Point”, and at the peak of the anomaly, the resonant frequency was close to 1.9 MHz; a phenomenal change. Continuing to re-sweep the analyzer over the next 5 minutes showed a gradual decrease in resonant frequency back toward the beginning point, but not getting completely back to the original resonant frequency of 1.825 MHz. Another set of clues: large frequency change; apparent high degree of hysteresis, and not entirely reversible.

Considerable information had been developed; what did it all mean? First and foremost, the evidence was mounting that some type of coupling at a high current point was in play, and the conditions of this coupling were power/temperature sensitive. A high degree of coupling was indicated by the extreme pulling of the resonant frequency from 1.8 to 1.9 MHz. Something far away, loosely coupled, could not do this. The phrase “far away” must be viewed in terms of wavelengths at the frequency of use, not just linear feet.

The only thing in the near vicinity of the inverted-L was the 80m inverted Vee. I started thinking that 1.8 MHz x 2 is 3.6 MHz; close to the resonant frequency of the inverted Vee. Upon dropping both legs of the inverted Vee to ground level ( feedpoint still near the top of the tower) and retesting, the anomaly occurred quicker and appeared more intensified than experienced in any other test scenario. I hypothesized that in this configuration the coupling between the vertical part of the inverted-L and the inverted Vee was greater, thus quicker onset of the anomaly. I lowered the tower.
